# UPGRADING A LIME KILN CHAIN SECTION TO REDUCE DUST LOADING AND IMPROVE THERMAL EFFICIENCY

Peace River Pulp Division  
Daishowa Marubeni International Ltd.  
Peace River, AB CANADA

## ABSTRACT

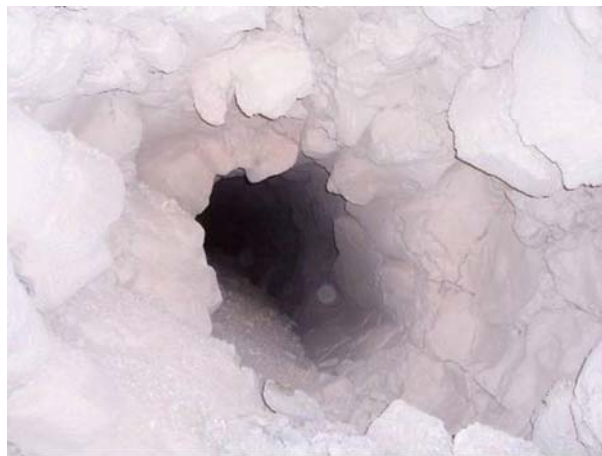
Recycled dust is an integral part of normal kiln load. Dust purging thus removed a portion of the normal kiln load and resulted in variable kiln load (product bed depth) along the length of the kiln. This made it difficult to judge how much heat was required at any one time to adequately calcine the lime mud feed, and resulted in undesirable kiln thermal cycles. Kiln thermal cycles exacerbated ring buildup downstream of the chain section (Figure 1). Ring formation accelerated local gas velocities and allowed more solids to accumulate behind the ring, as schematically shown in Figure 2. Some of the accumulated solids were then entrained in the high velocity gas stream as dust. Thus a cycle of dust purging - thermal cycle - ring formation - accelerated gas velocities - entrained dust - dust purging - continued to perpetuate itself.

**Figure 1.** Ring formation in the PRPD lime kiln

Prior to the chain system upgrade, ring formation downstream of the chain section near the middle of the kiln was a common occurrence (Figures 1 and 13). The build-up was generally difficult to eradicate, and had to be periodically physically removed using the Powershot nozzles. Since the chain system upgrade, the formation of mid-kiln rings seemed to have occurred less frequently. The rings seem to be softer and Powershot operation is not required as often as before the upgrade.

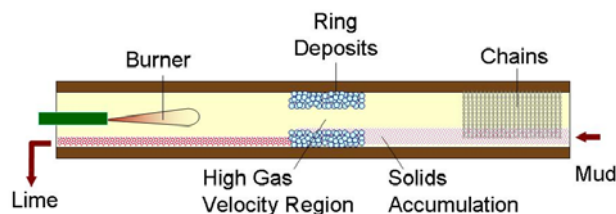
**Figure 2.** High gas velocity and solids accumulation at the ringing location

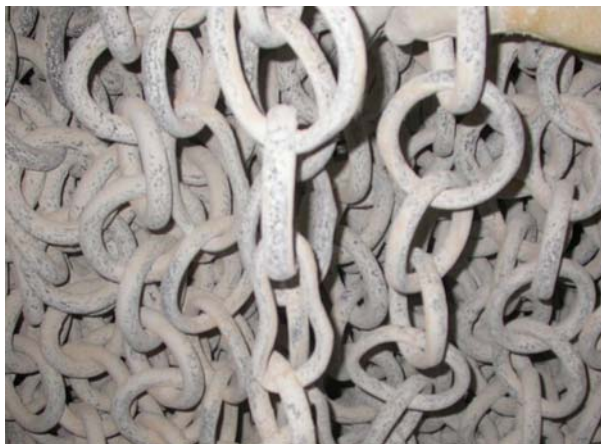
Increased lime production necessitated burning additional natural gas. The original round-link chain was unable to withstand the extra heat and began to thin and burn-out more rapidly (Figure 3). Hangars began to fail, and entire

lengths of chain appeared in the product lump crusher. The resulting lack of heat transfer surface area in the chain section increased natural gas consumption and caused feed end gas temperatures in excess of 300°C. High exit gas temperatures, in turn, thermally damaged the baghouse socks of the dust handling systems, exacerbating the dust handling issues.

**Figure 3.** *Thinned and warped round-link chain*

In June 2004, the kiln cold end internals were completely removed and an entirely new chain system installed. The new chain system consisted of: a shroud over the lime

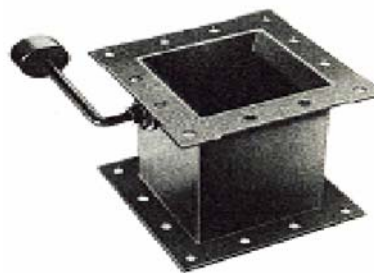
1. although the system was rated for only 288 Mt/d, investigation of individual equipment capacities revealed that most of the equipment possessed capacity in excess of the rated amount, with the exception of one rotary feeder;
2. tramp air pulled into the baghouse of the vacuum dust handling system fluidized the dust in the baghouse. The dust collected in the baghouse until it eventually collapsed into the mud feed screw in large spurts. Due to lack of mixing time available to moisten the large amounts of dust being periodically dumped into the mud feed screw, the dust was immediately entrained in the gas stream again upon entering the kiln.

**Figure 4.** *Trickle valve installed on outlet of baghouse*

remainder of the system was achieved. To address the second problem, a trickle valve (Figure 4) was installed on the outlet of the baghouse; this valve effectively prevented tramp air from entering the baghouse and evened out flow of dust into the lime mud feed screw.

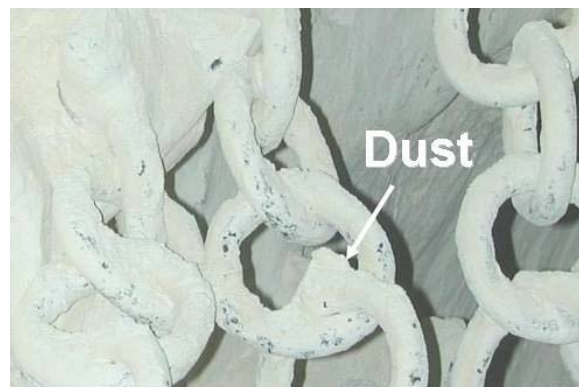
1. an excess of burned-out and thinned chain had reduced the chain density in the kiln to 112 kg/Mt lime, which was significantly lower than the recommended chain density of 150 kg/Mt lime for modern lime kilns;
2. the design of round-link chain was such that small “dust scoops” were formed by link connections (Figure 5). The mud collected by these “dust scoops” was carried out of the solids bed and released into the gas stream as the kiln rotated, negatively impacting dust loading.

**Figure 5.** *“Dust Scoops” formed by round-link chain*

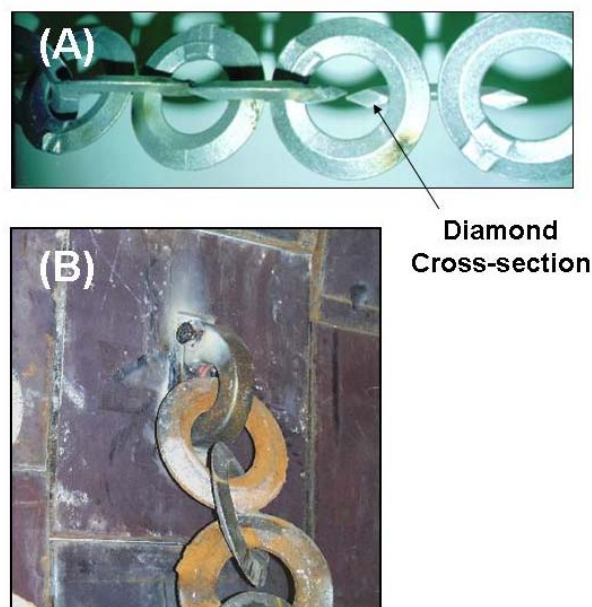
**Figure 6.** (A) Jammco's diamond-link heat exchange chain metal, and (B) Econoliner as insulation medium and attachment point for diamond-link heat exchange chain.

mud feed screw; 3.5 m of 813 mm tall, angled feed spirals; 5.6 m of carbon-steel round-link chain in the drying zone; 9.2 m of stainless-steel diamond-link heat exchange chain in the preheating zone (Figure 6A); and metal econoliner plates with replaceable link hangar caps and bases (Figure 6B). The complete new chain system was supplied by Jammco of Barrie, Ontario, Canada.

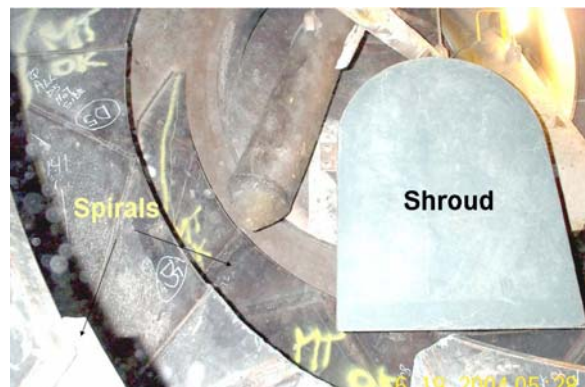
**Figure 7.** Mud feed screw shroud (right) and feed spirals (left and bottom)

1. the shroud over the mud feed screw (Figure 7) prevented dust being recycled into the kiln from immediately entraining in the exiting gas;
2. the high angle feed spirals (Figure 7) promoted mixing and turnover of solids in the feed end, preventing the top layer of mud from drying out prematurely and entraining in the gas steam;
3. the relatively sharp edge diamond-link heat exchange chain (Figure 6A) was designed to cut through the product layer rather than scooping it up as it is the case for the round-link chain (Figure 5). Furthermore, the number of link connections was halved as a result of the larger surface area inherent to the diamond-link chain style. The weight and metallurgy of the diamond-link chain also made it more resistant to thinning and burn-out.
4. the metal econoliners (Figure 6B) replaced castable refractory as the insulating medium in the chain

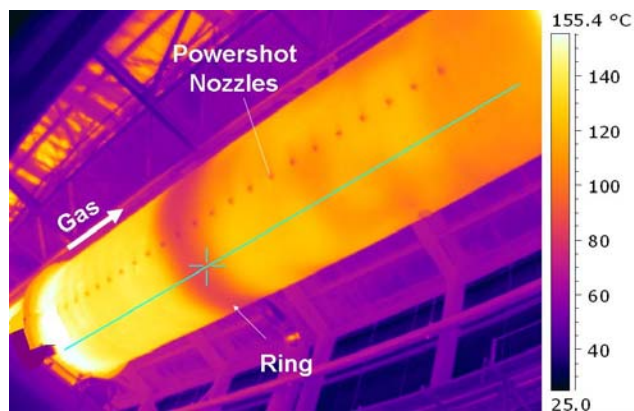
**Figure 13.** Thermography scan of kiln hot end shell showing ring formation downstream of chain section and powershot nozzles

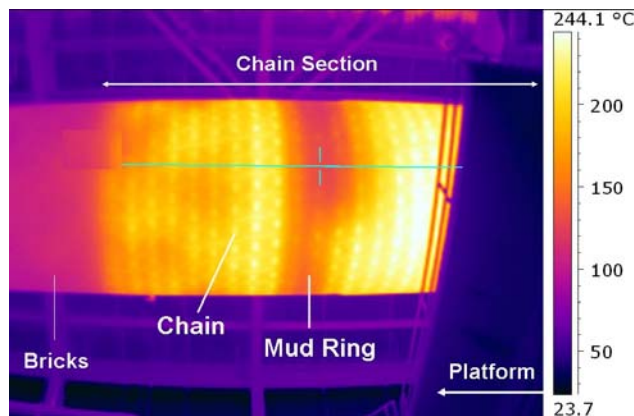
In the chain section, mud rings are found to form occasionally (Figure 14). They are soft and can usually be removed by introducing a deliberate thermal cycle into the kiln. However, there have been occasions since the chain system upgrade when the build-up in the chain section has limited lime production to the point where purchased quicklime has been required to maintain mill production rate.

**Figure 14.** Thermography scan of kiln chain section shell showing chain section ring
