# UPGRADING A LIME KILN CHAIN SECTION TO REDUCE DUST LOADING AND IMPROVE THERMAL EFFICIENCY

Peace River Pulp Division  
Daishowa Marubeni International Ltd.  
Peace River, AB CANADA

## ABSTRACT

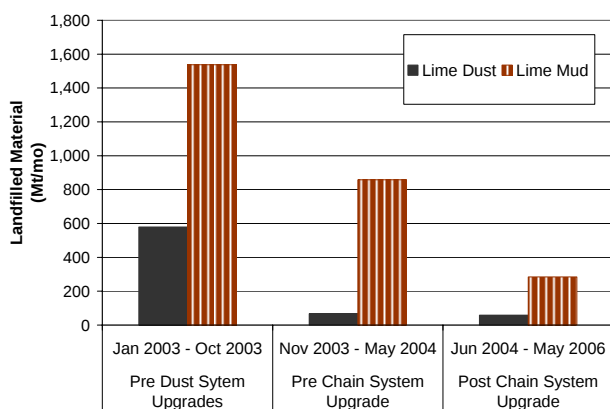
**Figure 8.** Amount of lime dust and lime mud landfilled since 2003.

A significant reduction in kiln dust loading resulted from the chain section upgrade. Following the chain system upgrade, dust loading is estimated to be about 50% of that before the chain system upgrade. This estimate is based on the fact that it is now possible to run the pressure dust handling system, which has a maximum capacity of 144 Mt/d, alone for up to 4 hours without plugging it off. This allows maintenance work to be completed on the vacuum dust handling system while continuing to operate the Lime Kiln.

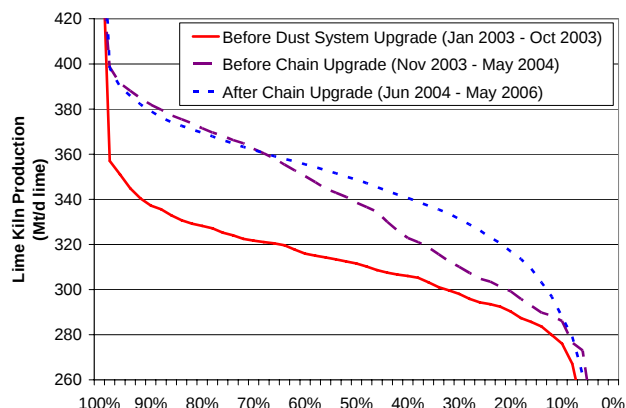
**Figure 9.** Kiln production duration curves

Figure 9 shows three duration curves for kiln production rate. The kiln production increased substantially as a result of the dust handling system upgrade; the difference between the pre dust handling system upgrade curve and the pre chain system upgrade curve represents 8,720 Mt/yr CaO. It is also worth noting that the 90<sup>th</sup> percentiles on the pre chain system upgrade curve and the post chain system upgrade curve are both in the neighborhood of 380 Mt/d lime, indicating that the dust handling system upgrade alone improved the kiln MSR sufficiently to achieve the 380 Mt/d required to support the current mill production.

Figure 9 also shows that the pre chain system upgrade curve drops off sharply at around 68<sup>th</sup> percentile. This indicates that the large dust loading still present in the kiln following the dust handling system upgrade was counterproductive to stable kiln operation, and that high production rates were not sustainable for long periods of

time. The amount of lime mud that still had to be landfilled before chain system upgrade is also indicative of unstable kiln operation.

The chain system upgrade resolved the kiln dust loading issue, and the difference between the pre chain system upgrade curve and the post chain system upgrade curve represents 2,300 Mt/yr CaO. Figure 10 shows that the chain system upgrade was responsible for substantially reducing quicklime purchases.

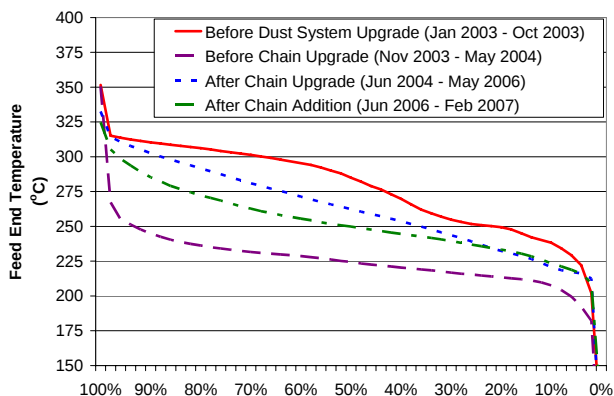
**Figure 11.** Kiln feed end temperature duration curves.

Figure 11 presents four duration curves for feed end temperature, and shows a significant reduction in feed end temperature as a result of upgrading the chain system. The feed end temperature exceeded 300°C 34% of the time before the dust handling system was upgraded and only 4% of the time post chain addition. It is important to remember that between November 2003 and May 2004 (concurrent with the dust handling system upgrade), the kiln feed end temperature was controlled by decreasing lime mud solids to 70-72% and adding water to the lime

mud feed: thus the low feed end temperatures for this period of time. Both of these measures were discontinued after the chain system was upgraded.

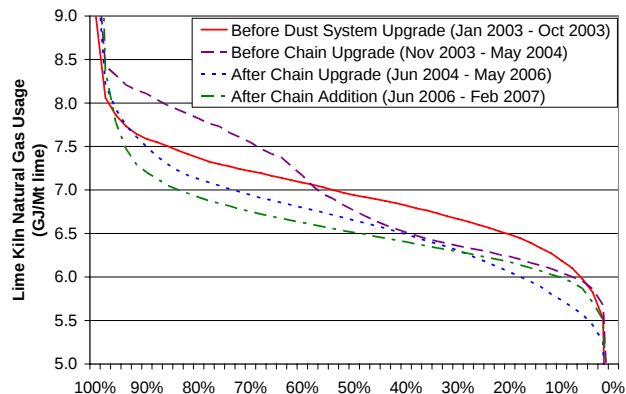
**Figure 12.** Kiln natural gas consumption duration curves.

Despite these complications, the chain section upgrade proved to be beneficial in reducing natural gas usage. Figure 12 presents four duration curves for kiln natural gas consumption. The reduction in dust purging as a result of the dust handling system upgrade positively impacted natural gas consumption; however, reducing lime mud solids and adding water to the lime mud feed to control feed end temperature resulted in thermal inefficiencies.

These conflicting conditions can be seen in the erratic nature of the pre chain system upgrade duration curve.

Figure 13 also shows that before the dust system upgrade, kiln natural gas consumption was less than 7 GJ/Mt lime only 52% of the time, whereas after the chain system upgrade, kiln natural gas consumption was less than 7 GJ/Mt lime 72% of the time. This improvement is impressive given that it includes heat losses introduced by removing the insulating brick in the burning zone. After additional chains were added in June 2006, kiln natural gas consumption was less than 7 GJ/Mt lime 82% of the time.
